### In a heavy smoker - Biodenta<sup>®</sup>-Implant placement

## Case Report - Dr. med. dent. Steffen Ulbrich, St. Gallen, Switzerland

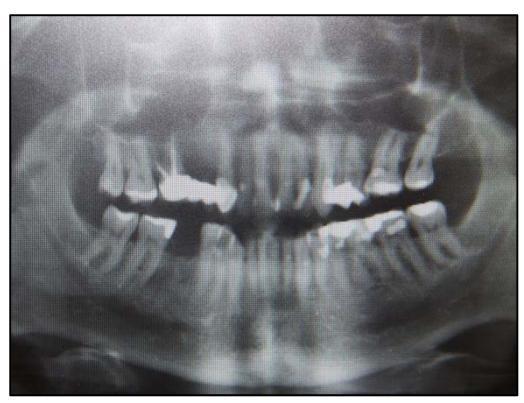
Fig. 4: Panoramic radiograph at examination

A 38years old male patient wishes to replace the lost tooth #46. This tooth was extracted three years ago due to an endodontic failure. The radiographic examination (panoramic) shows sufficient vertical bone height.

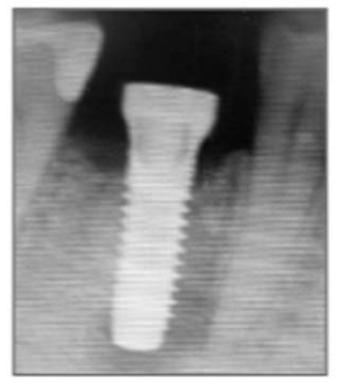
Fig. 5: Follow-up radiograph

A follow-up review was conducted and a peri-apical radiograph was taken revealing peri-implantitis surrounding the implant #46.The peri-apical as well as the panoramic radiograph (Fig. 5 and 6) shows 3 mm of bone loss mesial and distal of the implant. The patient has no discomfort to date.

After raising a small sub-periostal flap moderate circular and horizontal bone loss was detected around the implant.

The granulation tissue was thoroughly removed with a plastic implant-curette.

The exposed implant surface was rinsed with a phosphor-acid solution (20%) for 30 seconds followed by saline solution for another minute. The bony defect was filled similar to the conventional GBR technique with an alloplastic bone filler and covered with a collagen membrane. Figures 7 and 8 radiograph illustrate the post-surgical bone level.

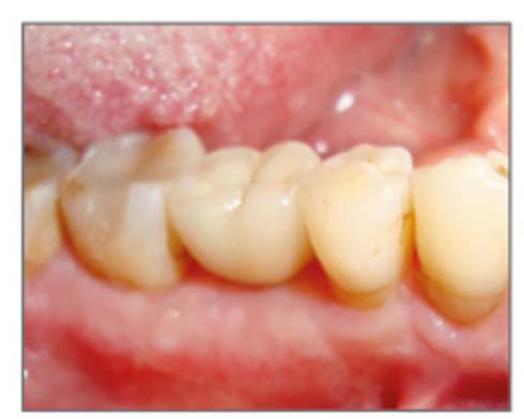
Fig. 21: Cementation of completed implant crown #46

The straight abutment was inserted with a standard torque of 35Ncm (Fig. 20). The screw access canal was sealed with a cotton pellet and hydro-wax. Cementation of the crown followed with a provisional cement.
