Case report - Dr. med. dent. Steffen Ulbrich, St. Gallen, Switzerland

Biodenta[®] Tissue level Implants placement to establish the lost vertical dimension

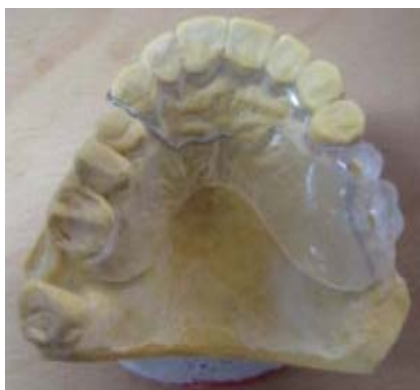
Fig. 4: Surgical Stent for the maxilla

Surgical Stents for the maxilla and mandible were manufactured in a dental laboratory, using prefabricated teeth in a set-up that was then converted into an acrylic guide. (Fig. 4 and Fig. 5)

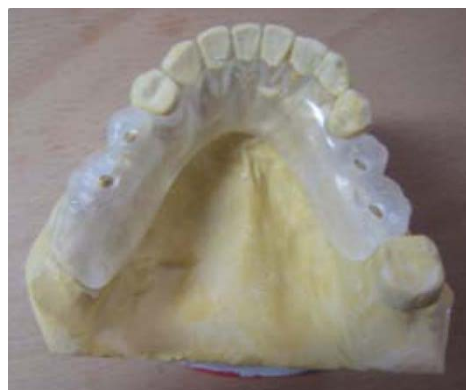
Fig. 5: Surgical Stent for the mandible

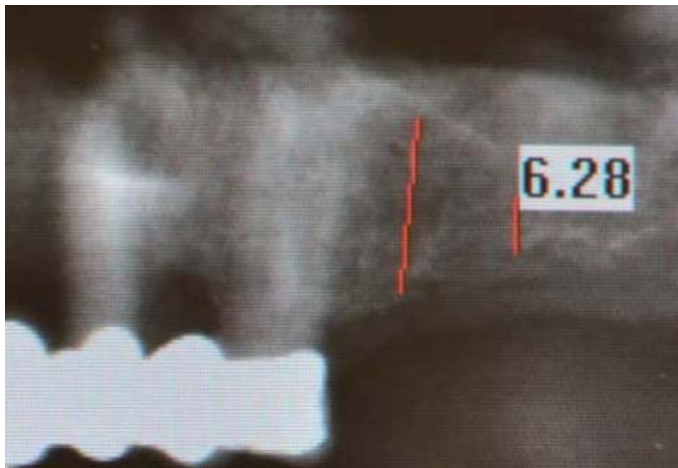
Fig. 9: Measurement of the vertical bone height

Measurements on the OPG indicated a bone height of 4-5mm at the #26 site. In this situation an internal sinus lift using Osteotomes (Summer's Technique) was performed (Fig. 9). A thorough radiographic analysis is essential in order to determine if a bone graft procedure is required. If the residual vertical bone height is less than 3mm a lateral sinus lift procedure is indicated.

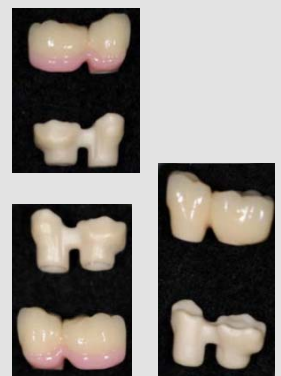
Fig.16:
Frameworks and finished lab-work after porcelain application

The final abutments were designed utilizing CAD/CAM software. They were milled from zircon oxide by a CAM machine. After sintering the frameworks, porcelain was applied using ceramics2in1

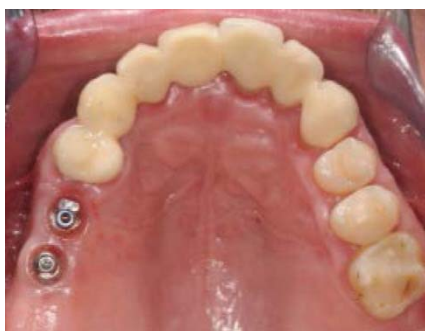
Fig. 17: Individual customised abutments

The individual customised abutments (Fig.17) were inserted using a positioning splint with a maximum torque of 35Ncm. The final crowns were cemented (Fig.18). The lateral view (Fig.19) demonstrates the harmonious integration of the new restorations within the existing dentition.

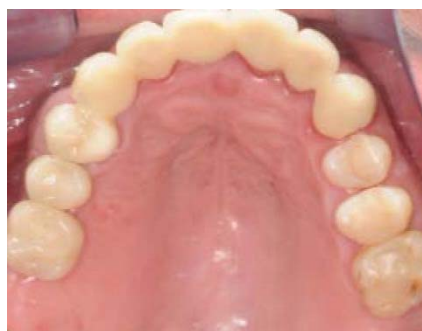
Fig. 18: Cemented crown and bridgework in the maxilla (Occlusal View)

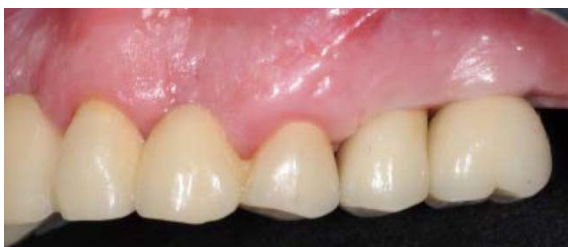
Fig. 19: Cementation of the crowns in the maxilla (Buccal View).

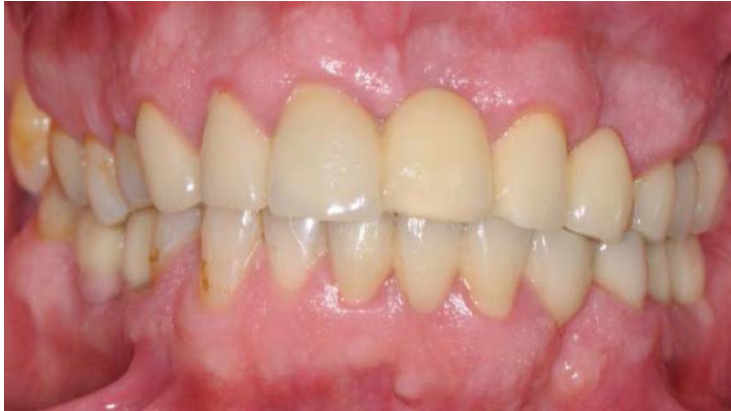
Fig. 20: The completed rehabilitation of the dentition

A balanced occlusion was established (Fig.20) with all the crown and bridgework demonstrating an excellent occlusal fit (Fig.21).

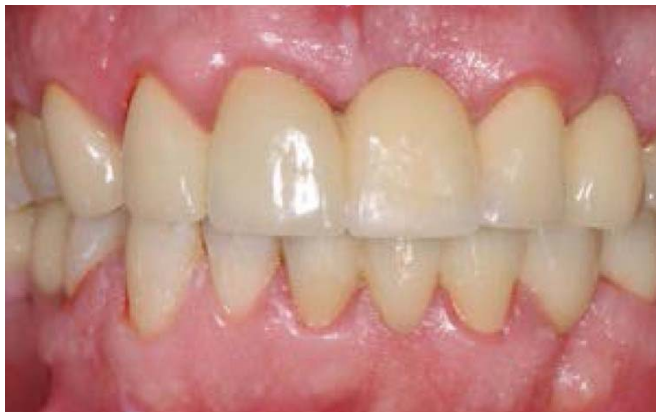
Fig. 25: Correction of the anterior reconstruction
