### In a heavy smoker - Biodenta<sup>®</sup>-Implant placement

## Case Report - Dr. med. dent. Steffen Ulbrich, St. Gallen, Switzerland

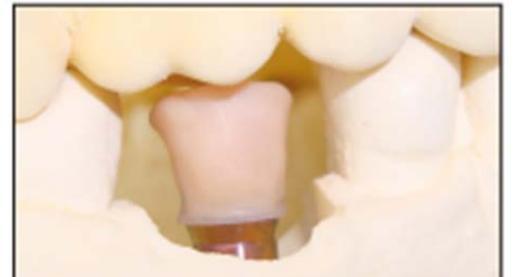
Fig. 17: The milled and coloured coping is ready for the porcelain application with "ceramics 2in1".

The wax-up was scanned and a CAD/CAM milled Zirconia coping was fabricated.

For the direct porcelain overlay of the Zirconia coping the ceramics2in1 - porcelain from Biodenta was used. Ceramics2in1 can be used for firing on titanium and Zirconia.
